DaimlerChrysler
India Private Limited

**Service Measure - Flash (CGW) central gateway.
Model 211**

Flash (CGW) central gateway
Model 211

Service Measure - Check parameter setting of control unit, track expanded short test. Model W211 and R230

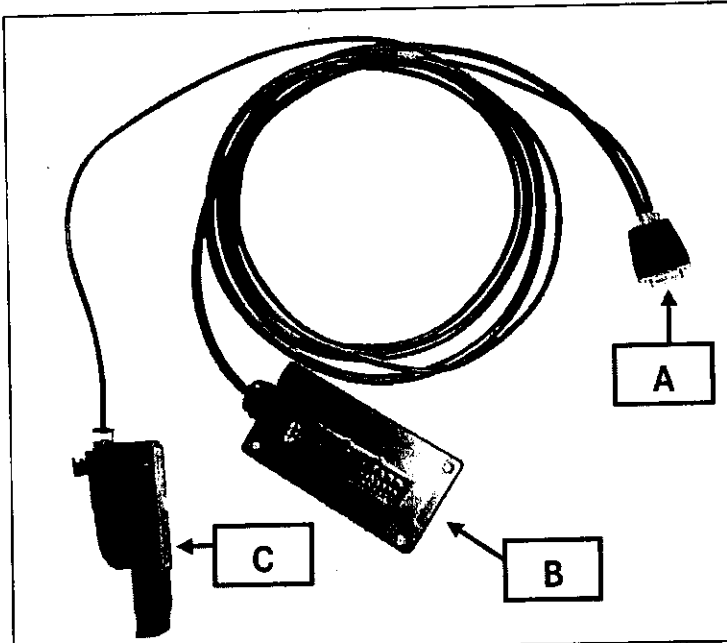
Fig. 1 - Adapter cable (15/47-pin)

- A) Plug A (15-pin, is connected to socket A of SBC module)
- B) Plug B (47-pin, is connected to engine wiring harness)
- B) Plug C (47-pin, is connected to SBC control unit)

7. Connect **plug A** of the 15/47-pin adapter cable (Fig. 1) to **socket A** of the SBC module (Fig. 2) and secure **plug A** using manual knurled screws.

9. Connect and lock **plug B** of 15/47-pin adapter cable (Fig. 1) to engine wiring harness plug.

10. Connect and lock **plug C** of 15/47-pin adapter cable (Fig. 1) to **connector strip C** (Fig. 4) of SBC control unit.

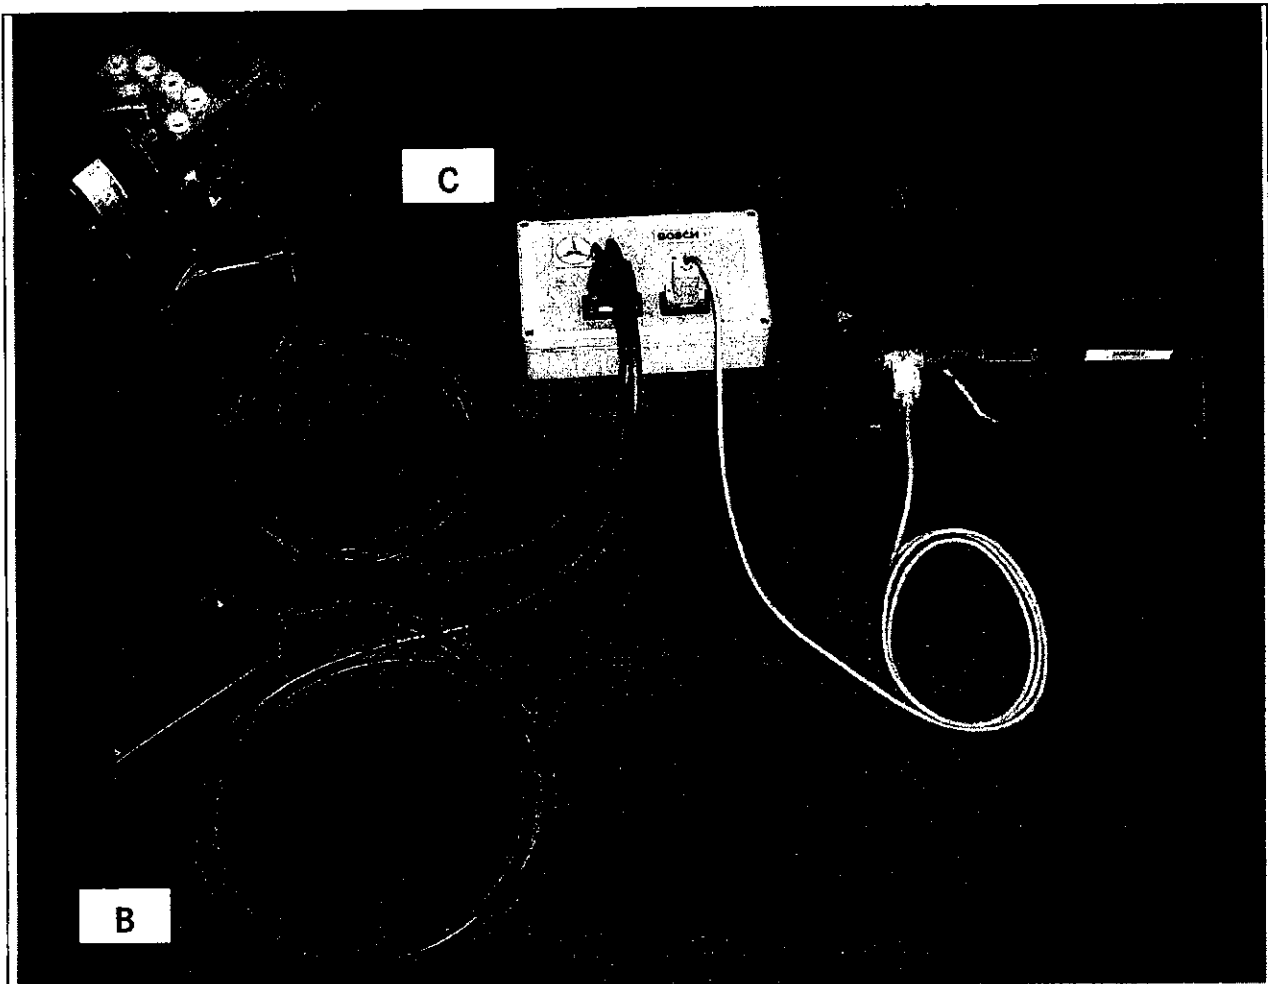
Fig. 4 - Assembly

- B) Plug B (47-pin, is connected to engine wiring harness)
C) Connector strip C (to SBC control unit)
