DAIMLERCHRYSLER

Pune, March 28, 2002

Customer Satisfaction Campaign – Rectification of possible water seepage in passenger compartment – W 203

To eliminate a chance of water seepage through sealant on W203

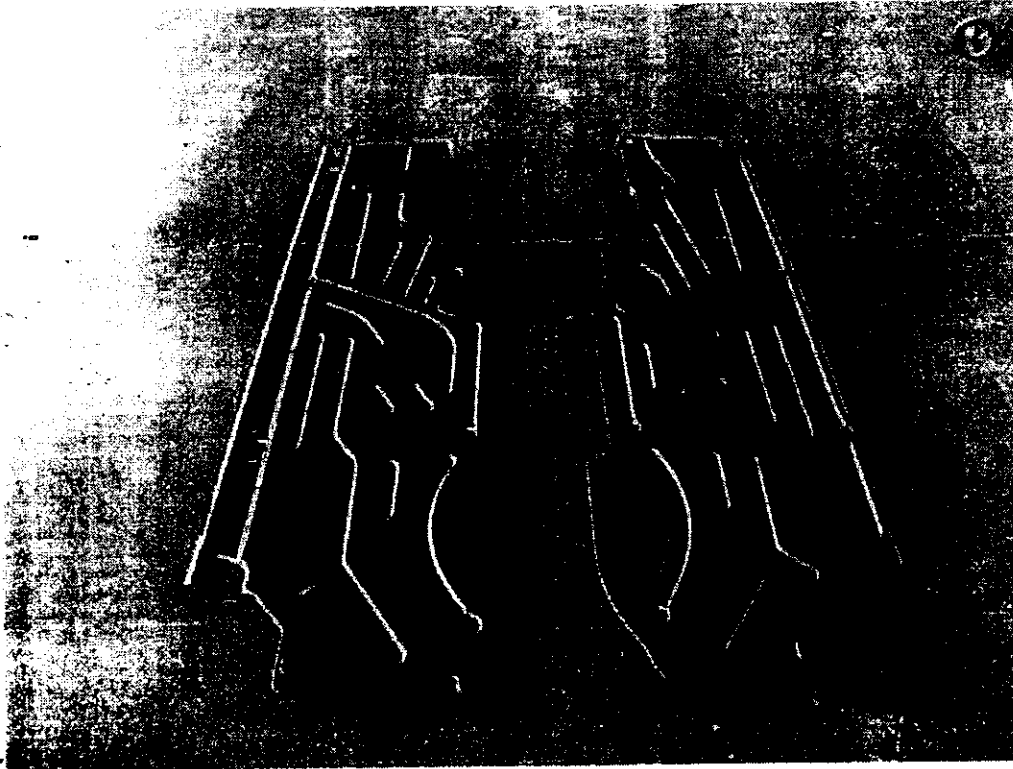
- 4 Check the sealant bid on the underbody under the rear seat, exactly on the sheet metal box section and the flooring on which fuel tank is mounted.

- 1 Raise the vehicle on two post / four post lift.
- 2 Wash the underbody of the vehicle.
- 3 Remove the under protection cover LH & RH
part number : LH A203 619 01 38
RH A203 619 02 38
