DaimlerChrysler
India Private Limited

Pune, June 11, 2003

Service Measure – Replace hose clamp on steering return hose, Model 163

Replace clamp on power steering hose

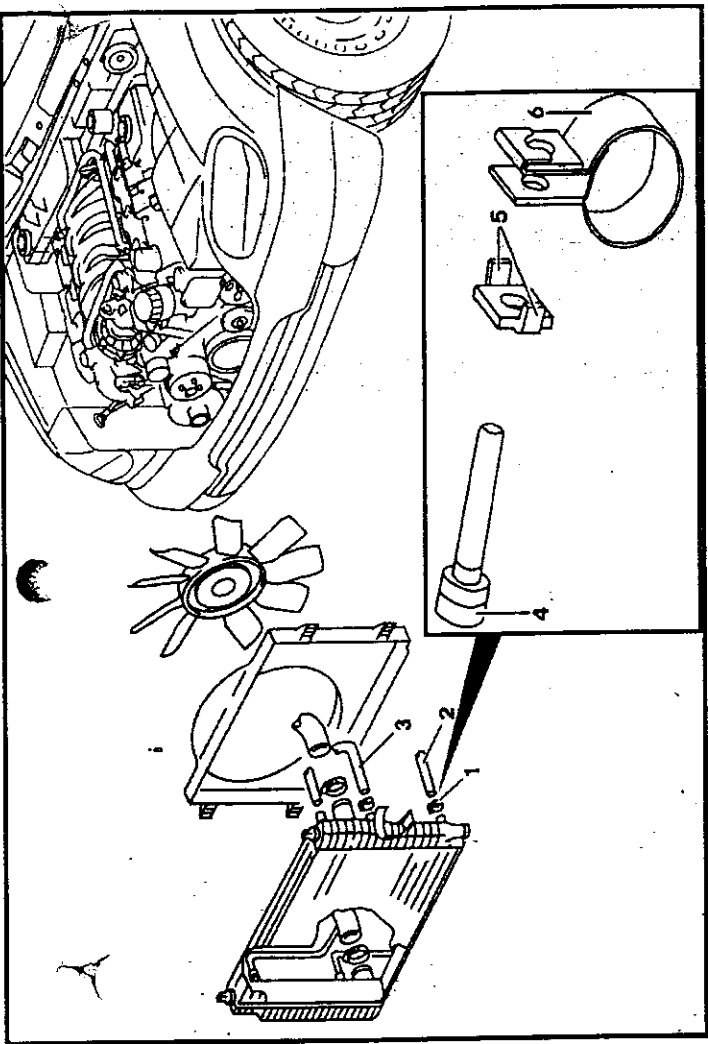
Illustrated on Model 163.154

We are in receipt of a subject service measure from DCAG on Model 163. On M Class vehicles (list of chassis nos. from your region enclosed), the steering return hose connection at the cooler may develop leak. In order to prevent the incidence of leakage from this area, we kindly ask you to replace the hose clamp on the return hose as a precautionary measure.

- 1 Clamp
- 2 Lower steering hose (steering gear → radiator)
- 3 Upper steering hose (radiator → expansion reservoir of power steering pump)
- 4 Screw
- 5 Anti-rotation tab
- 6 Clamp, replacement

- 1. Place vehicle on lift.
 - i Model 163.113 only **WIS Document: AR00.60-P-1000GH**
- 2. Turn off engine and remove ignition key.
- 3. Open hood.
- 4. Clamp upper (3) and lower (2) power steering hoses using specified hose clamping tools.
 - i 000 589 40 37 00
- 5. Remove front section of noise encapsulation.
 - i Model 163.113 only **WIS Document: AR94.30-P-5400GH**
- 6. Loosen existing lower clamp (1) and slide clamp down hose away from radiator fitting.
 - i DO NOT detach or disturb hose in order to prevent fluid loss.
- 7. Inspect condition of lower steering hose (2).
 - i Hose should NOT be replaced unless outer casing exhibits cuts or splits.

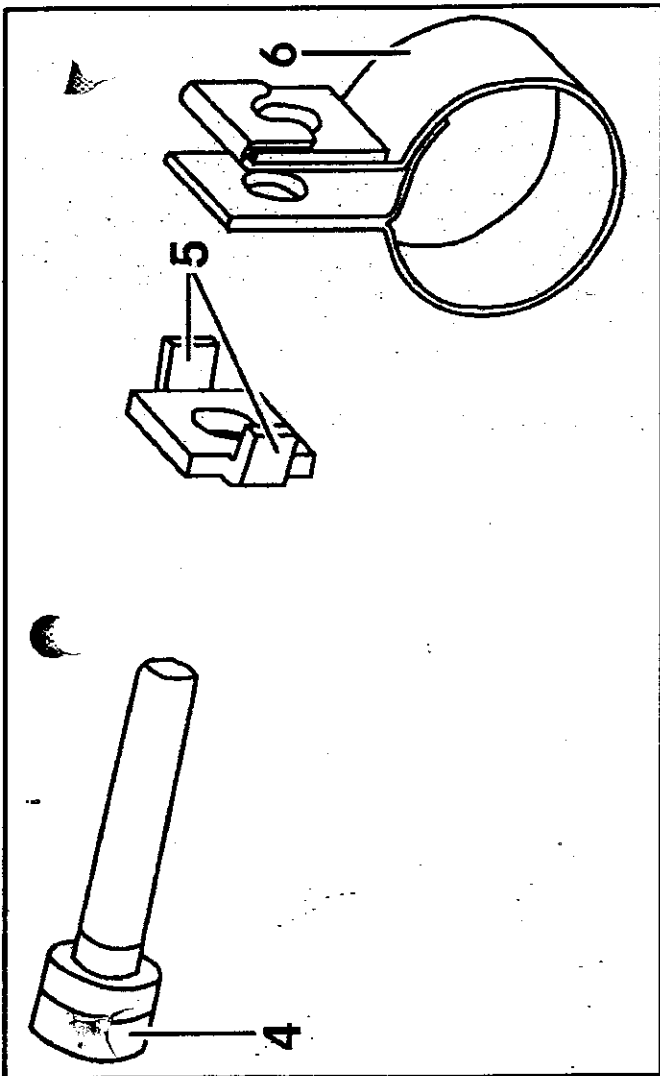
- 4 Screw
- 5 Anti-rotation tab
- 6 Clamp, replacement

8. Open replacement clamp (6) to fit over lower steering hose (2).
 - p Do not open clamp more than just enough to fit over hose, or clamp may be damaged.

- i New clamp **MUST** have "Nr St 15" stamped on outer surface. Other hose clamps must **not** be used.
9. Secure replacement clamp (6) in proper position around lower steering hose (2) and tighten screw (4).

- p Observe proper torque specification! Ensure proper orientation of anti-rotation tabs (5).
 - n 2.0 +0.5 / -0
 - i Do not exceed torque value, even if hose can still be rotated on fitting.

10. Open previous clamp (1) sufficiently to remove from around lower steering hose (2).
 - i Discard clamp (1).
11. Remove specified hose clamping tools from upper (3) and lower (2) power steering hoses.
