Service Measure – Seal bottom strip on doors.
Model W203 and W220

- 203.### (except 203.7) # A up to 480000,
- 203.### (except 203.7) # F up to 380000,
- 203.### (except 203.7) # R up to 480000,
- 220.### #A up to 334898

SM72.00-P-0002A	Seal lower strip on doors	23.7.04
-----------------	---------------------------	---------

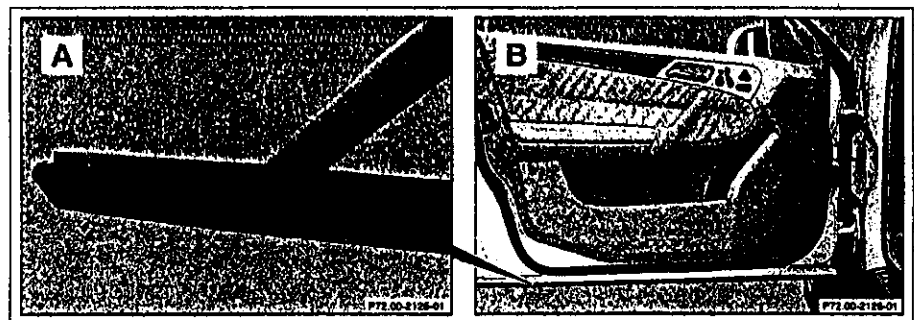
P72.00-2127-04

As per the information received from DCAG, the seal at the bottom strip on the doors of the above model series manufactured up to December 2002 may be insufficient. Therefore, it is requested to apply additional sealing compound to these strips during next workshop visit of these vehicles. The list of affected vehicles is attached herewith. Please refer the enclosed work instructions for this action.

1	Remove lower strip on doors		
2	Thoroughly clean lower strip and doors with silicone remover blow dry with compressed air	Ⓢ To ensure proper adhesion, there must be no cleaning agent residues remaining.	
3	Fill lower strip with sealing compound	1 Insert nozzle of sealing agent cartridge as far into the strip as possible (picture A).	BR00.45-Z-1088-01A
		1 The strip is sufficiently filled if the material is clearly visible.	
4	Install lower strip on doors	1 Remove excess material using a rubber wedge.	
5	Clean doors and strip following installation		
6	Repeat procedure on all doors
