**Recall Campaign**  
**Replace crankshaft position sensor**  
**Models 164, 211 and 221 with engine OM642**  
**Accounting No. 1593034.**

## WORK DESCRIPTION FOR SERVICE MEASURE

### Replace crankshaft position sensor

Model 211; 221; 164 with OM 642

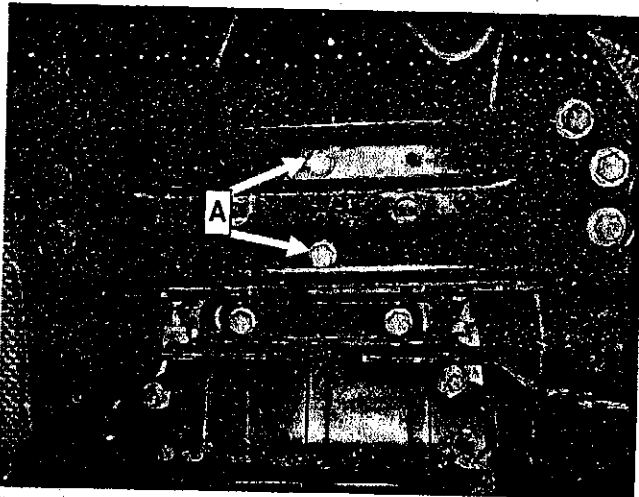
Figure 1

- Remove coolant hose at firewall.
- Remove bracket of rear soundproofing.
- Loosen bolts (A) at crossbar from rear engine mount to transmission (**Nm** 50; figure 1).

- Lift engine at rear of transmission.
3. Assemble in the reverse order.
    - i** Reading out and erasing the fault memory is **not** necessary.
