<dhananjay.pathak@daimler.com>; <dinesh.naniwadekar@daimler.com>;
 <rameshan.nair@daimler.com>; <sunil.dagar@daimler.com>;
 <michael.m.helfrich@daimler.com>; <presanna.kumar@daimler.com>;
 <yadunath.kulkarni@daimler.com>; <tushar.siddam@daimler.com>;
 <milind.desai@daimler.com>; <laxmikant.gavankar@daimler.com>;
 <vaibhav.adwant@daimler.com>
Sent: Friday, November 28, 2008 3:16 PM
Attach: SI - Air Intake Hose - 101108.PDF.zip; Affected Vehicles - CSC - Fittment of Tie Strap on Air Intake Hose - W 204.xls.zip
Subject: Customer Satisfaction Campaign - Fittment of Tie Strap on air Intake hose - W 204 - C 220 CDI - Accounting number 0912238.

Subject: Service Information - Model C220CDI/ W204 - Tie strapping of Air Intake Hose

S. I. No. - IND 09/ 002

Applicable to Model: C220CDI/ W 204

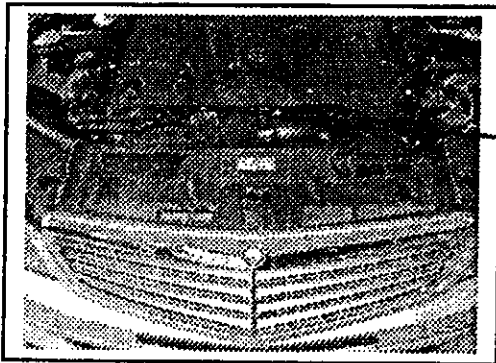
- The lower & upper portion of Air intake hose are splitting/ opening.
- The lower portion of Air intake hose dislocates from its location and falls inside the engine compartment. (Please see the appended photographs - Figures 1, 2 & 3)

Figure 1 - Position of Air Intake Hose

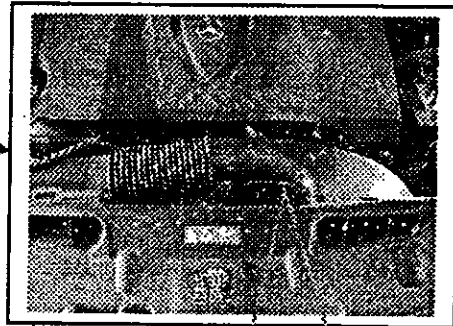
Figure 2
Lower portion & Upper portion of the air intake hose
splitting at the joint due to broken locking lugs

The locking lugs at the joint of lower & upper portion of the air intake hose breaking down due to excess wear.

It is thus essential to resecure the splitting lower & upper portion of the air intake hose with the help of a long tie strap (black colour) in such a way that air intake hose does not split-open at joint.

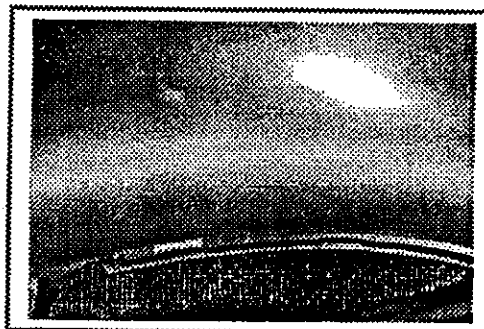
Figure 3 - Broken locking lugs
