DaimlerChrysler India Private Limited

Service Measure during next workshop visit 2011-R1230-Checkalternaton regulator and replace it, if necessary. Accounting No. 5493001.

WORK DESCRIPTION FOR SERVICE MEASURE

Replace regulator for alternator M 112/ M 113

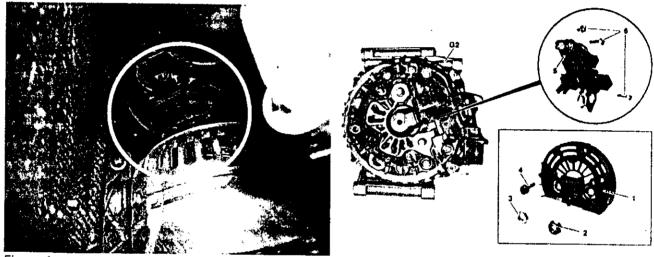
Figure 1

- 1. Connect Diagnostic Assistance System and start quick test.
- Check the manufacturer of the alternator (only for M 112, use a mirror, see picture 1) Note: If the installed alternator is made by Valeo, no further action needs to be taken. If the installed alternator is made by Bosch, see work procedures.
- **Note:** M 113 engines are only installed with Bosch alternators. Therefore, on these engines you can replace the alternator's regulator without having to check for the manufacturer.

- 1. Disconnect ground cable from battery (7 Nm).
- 2. Remove alternator (G2) (model 208 only, mounting bolt 42 Nm).
- 3. Partially remove lower engine compartment paneling.
- 4. Disconnect multiplug from regulator (5).
- 5. Remove caps from circuit 30 connection and disconnect electrical connections from alternator (G2) (nut for B+ on alternator 18 Nm).
- 6. Remove cover (1) by removing collar nut (2), nut (3) and then screw (4).
- 7. Remove screws (6) from regulator (5).

- 8. Replace regulator (5).
 - Note: Do not damage the carbon brushes in the process.
- 9. Perform basic programming.
- 10. Erase any faults that may have been stored.
