DaimlerChrysler
India Private Limited

Pune, February 7, 2002

Customer Satisfaction Campaign – Retrofitment of emergency drain valve on the air/water collector box, Model W 220 / W 215

Working instruction for retrofitting the emergency drain on water/air box

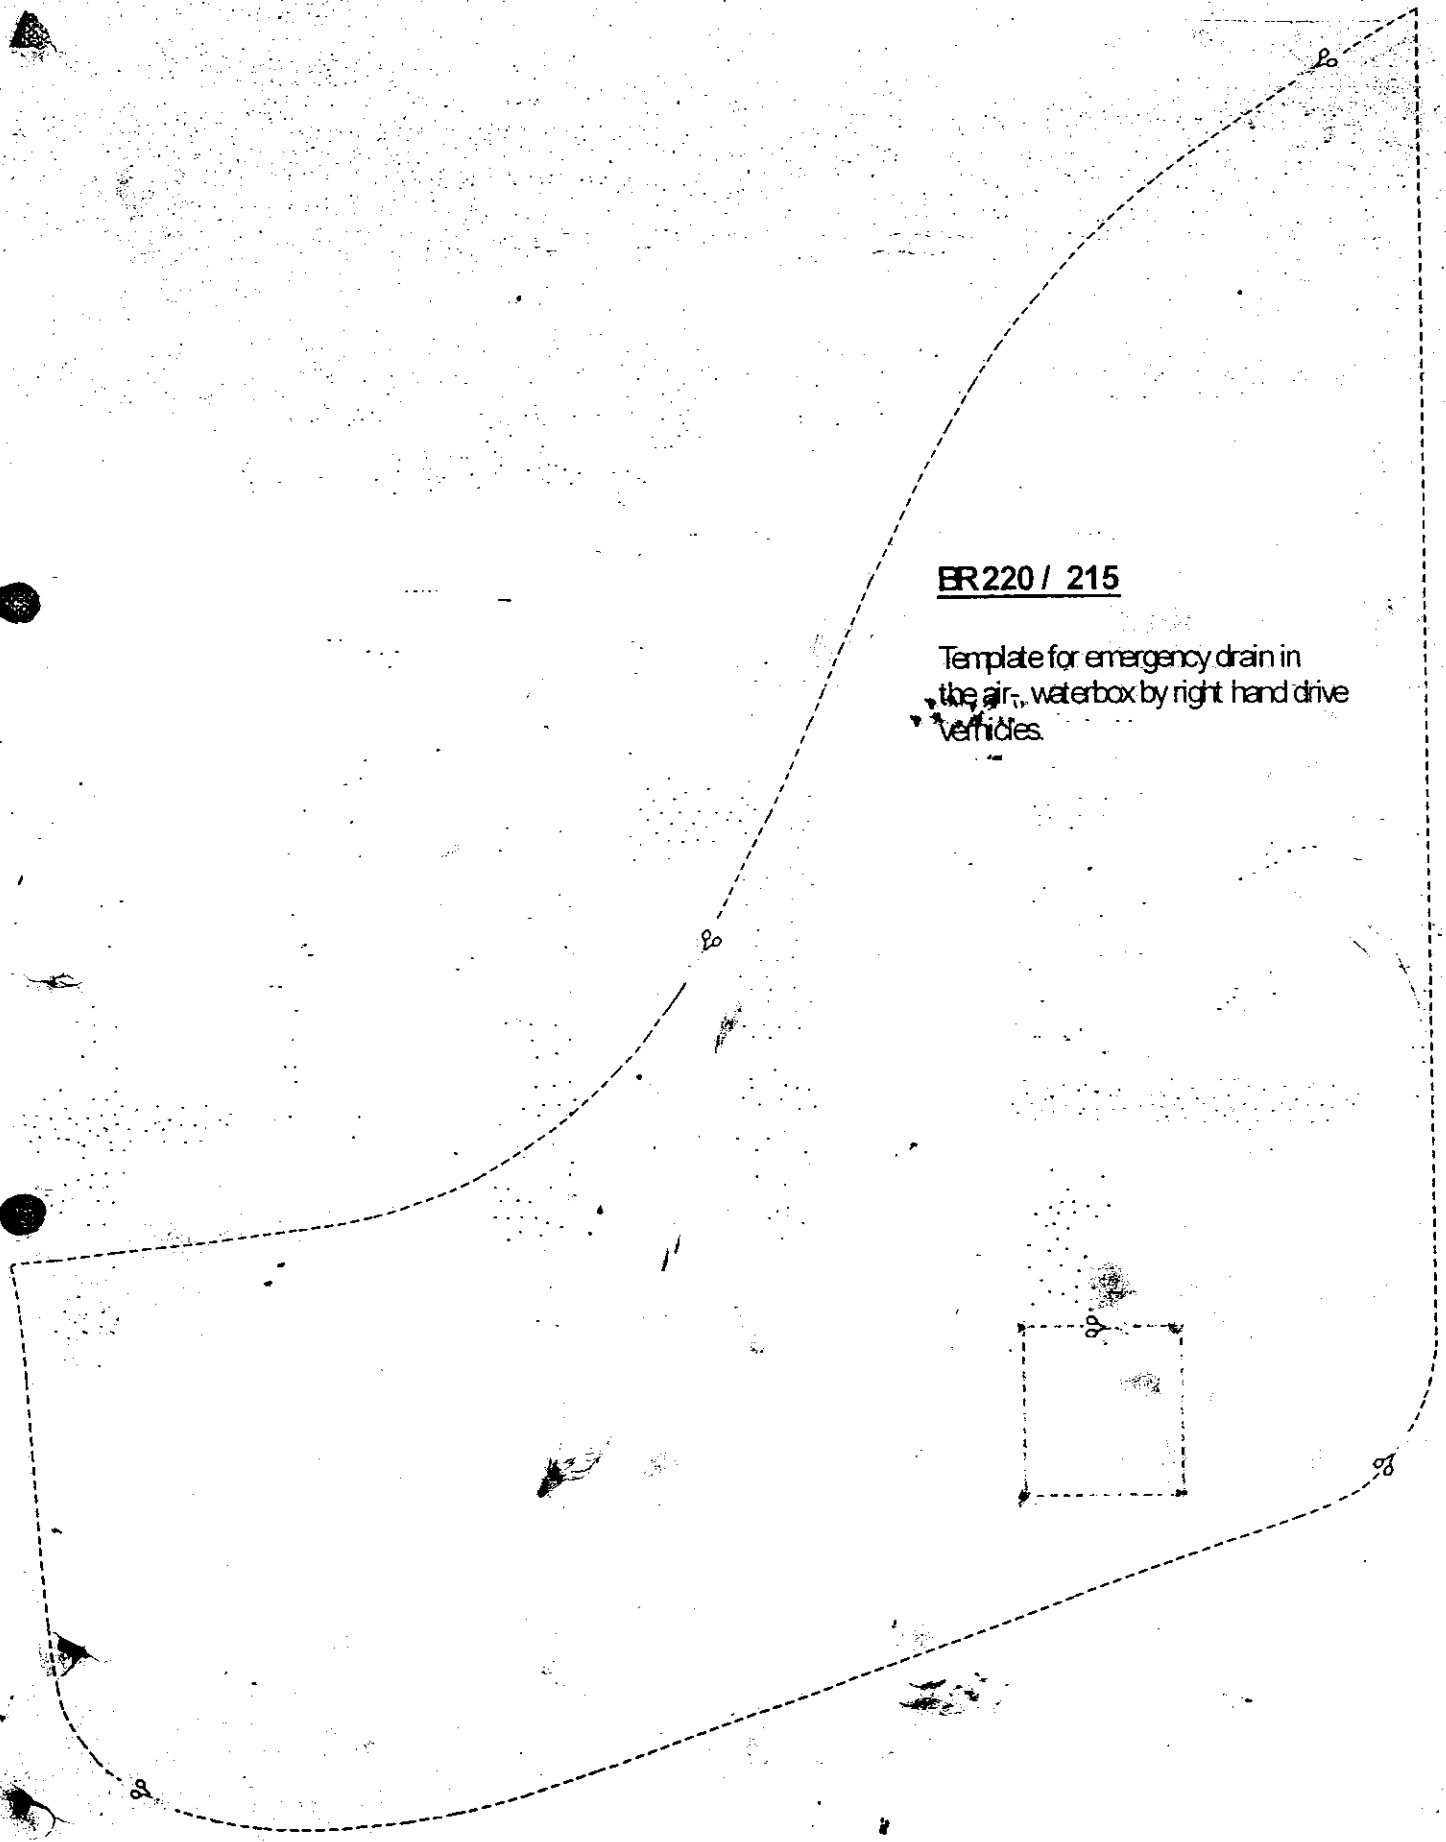
ER220 / 215

Template for emergency drain in
the air, waterbox by right hand drive
vehicles.

4. Fix (glue on) template on air collector box and water collector and mark cut-out with wax crayon.
5. Mark bore holes at all 4 edges and set them with $\varnothing 5,0$ mm (refer to fig. 2)
