Service Measure – Checking fold on rear left fender and applying the preservation agent, if necessary, Model 171

WORK DESCRIPTION FOR SERVICE MEASURE

Check fold on rear left fender and apply preservation agent if necessary
Model 171

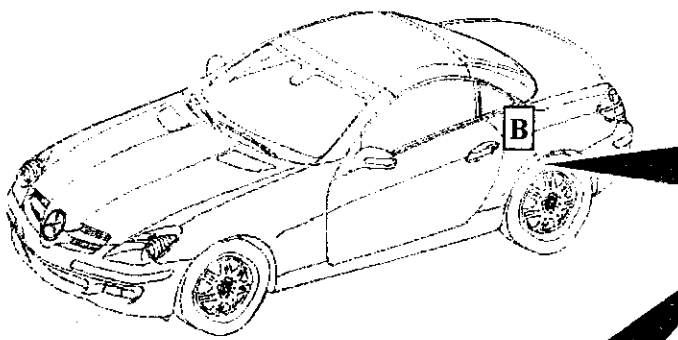
Figure 1

1. Remove stop plug (A) from wheelhouse (figure 2).
2. Thoroughly apply preservation agent to area B (figure 1).
i Insert hooked applicator into wheelhouse opening (C) and spray preservation agent in both directions (up and down, figure 3).
i Spray for about 4 seconds in both directions.
i Perform this step twice waiting approximately 5 minutes between applications.
3. Install stop plug (A) into wheelhouse.

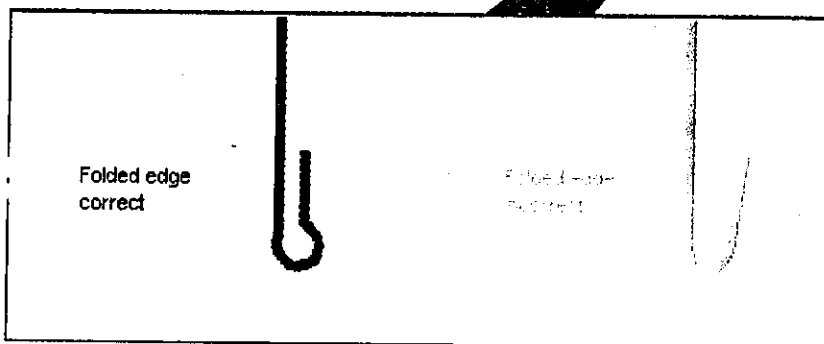
Figure 4

1. Check folded edge on rear left fender (figure 4).
i If the folded edge is **NOT** correctly folded, continue with the work procedure, **otherwise end measure.**
