Subject: MOST URGENT - Inspection of front shock absorber spring mounting disc - W 203

This is to inform you that we have observed isolated cases where a fine crack has been observed on spring mounting disc of front shock absorber of recently dispatched new C class vehicles. Please refer below mentioned photographs which show the exact location of the crack.

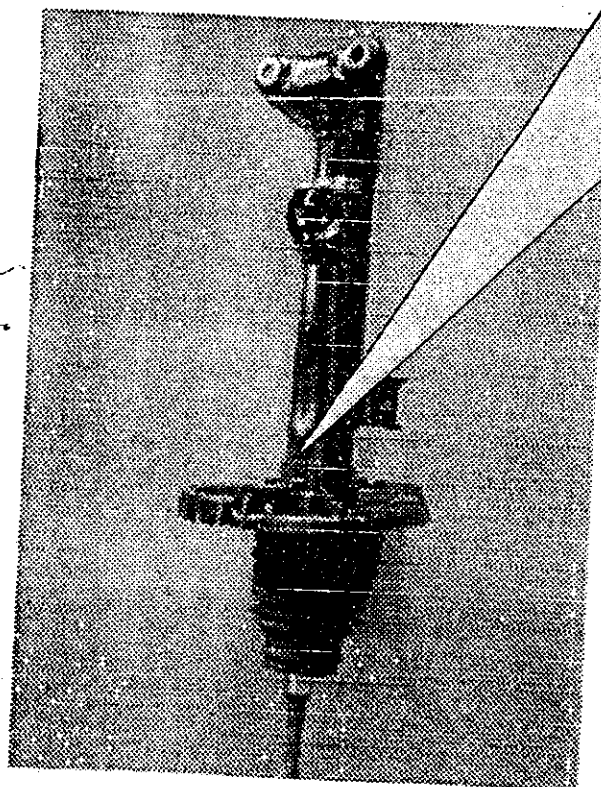
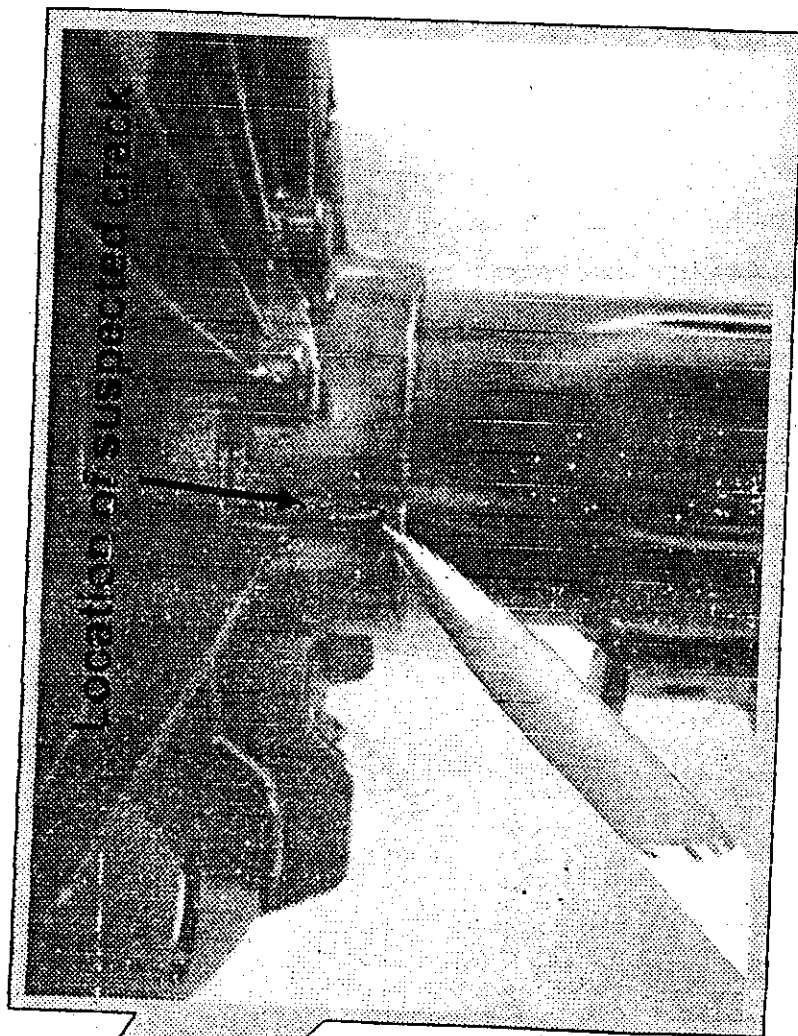
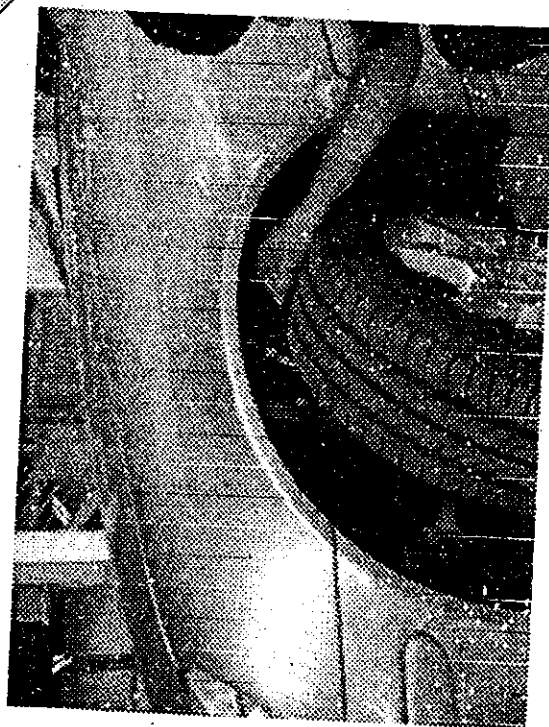
Inspection of W 203 front shock absorber  
spring mounting discs (left & right) can be  
done from the wheel arches as shown  
in the photograph.

You are requested to inspect all the undelivered C - Class vehicles presently available in your stock for this probable crack. The shock absorbers with cracked spring mounting disc are to be replaced immediately before delivery of vehicle to the Customers. You are also requested to report your observations (crack or no crack) immediately to us.
