Service Information

Passenger Car	Type : E 220 CDI & E 240	
Distribution : Deale	ers + Service Dealers

28th April 2000

Inspection of the air intake grill

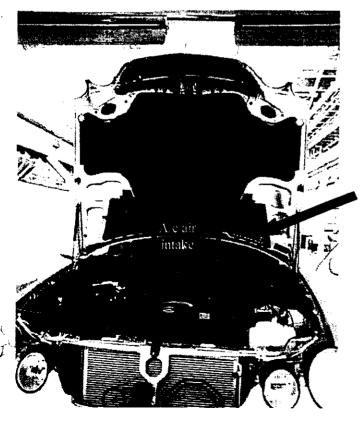
View the Bonnet top grill (EPC nomenclature is "covering -ventilation Screen"). This is located above the A/C intake-duct on the engine hood (marked by arrow). This should not be directly open to outside. In case this shows direct opening then fit the grill P. No. 210 880 08 05 and remove the grill originally fitted.

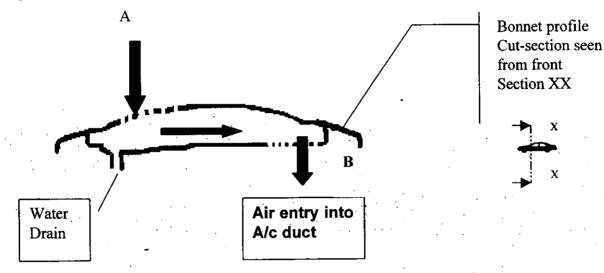
Direction of Airflow to air-conditioning system through fins on bonnet top. This is applicable for RHD vehicles.
