# DAIMLERCHRYSLER

## Service Measure - Check parameter setting of control unit, track expanded short test. Model W211 and R230

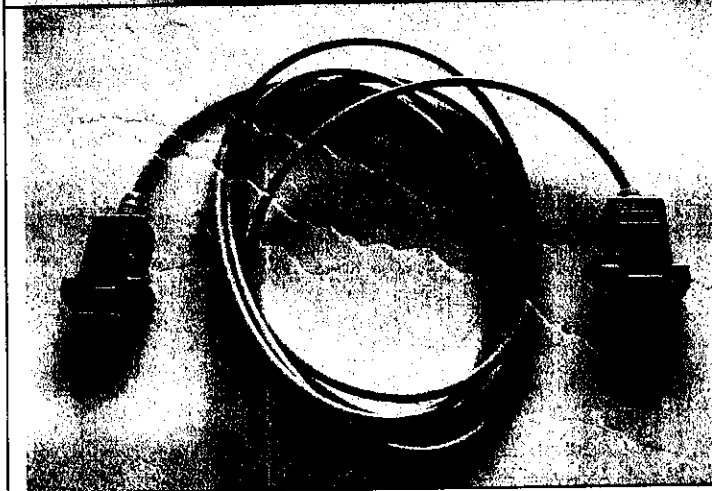
**Fig. 2 - SBC Module**

- A) Socket A (15-pin)
- D) Socket D (9-pin)

7. Connect **plug A** of the 15/47-pin adapter cable (Fig. 1) to **socket A** of the SBC module (Fig. 2) and secure **plug A** using manual knurled screws.

To do this, connect either plug of the connecting cable (Fig. 3) to socket D (Fig. 2) of the SBC module and secure using manual knurled screws.
