**Service measure during next workshop stay
Grease regulation linkage at turbocharger
Models 203 and 211 with OM 646**

WORK DESCRIPTION FOR SERVICE MEASURE

Grease regulating linkage at turbocharger (ATL)

Model 203; 211 OM 646

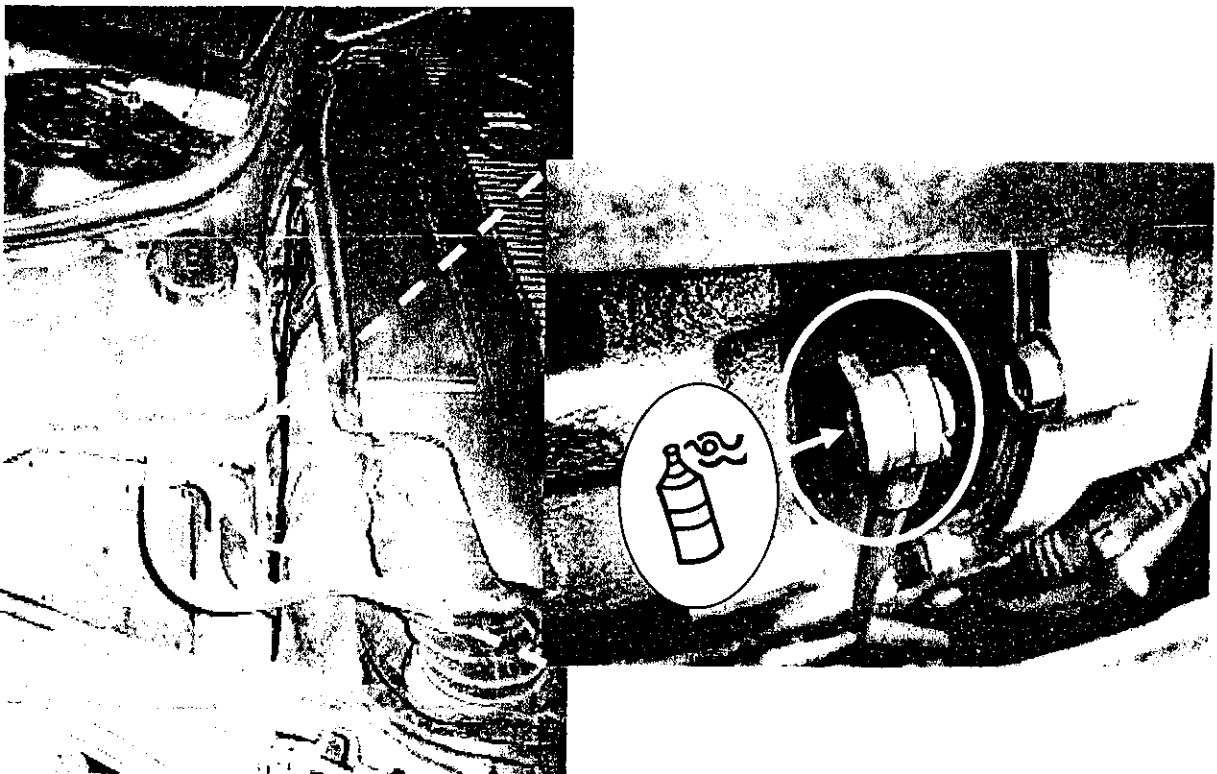
Figure 1

Please be informed that on model 203 and 211 vehicles with engine OM 646, the regulation linkage for the turbocharger may stick. In isolated cases this may lead to loss of engine power. Hence the turbocharger's regulation linkage needs to be lubricated on the vehicle's next visit to the workshop. The list of the affected vehicles is enclosed herewith. Please note that the locations mentioned in the list are only indicative and any vehicle mentioned in the list visiting your workshop has to be attended for this Campaign.

1. Open engine hood.
2. Spray ATL kinematics (adjustment shaft, joint) with "Ferroform Locc", (figure 1) and allow it to work in for 2 minutes.
3. Spray the ATL kinematics (adjustment shaft, joint) with "Gleitmo 165" as described in step 2.
